# **ENGINEERS REPORT**

**Sneinton,  
Nottingham.**

**Date: 01 September 2020**

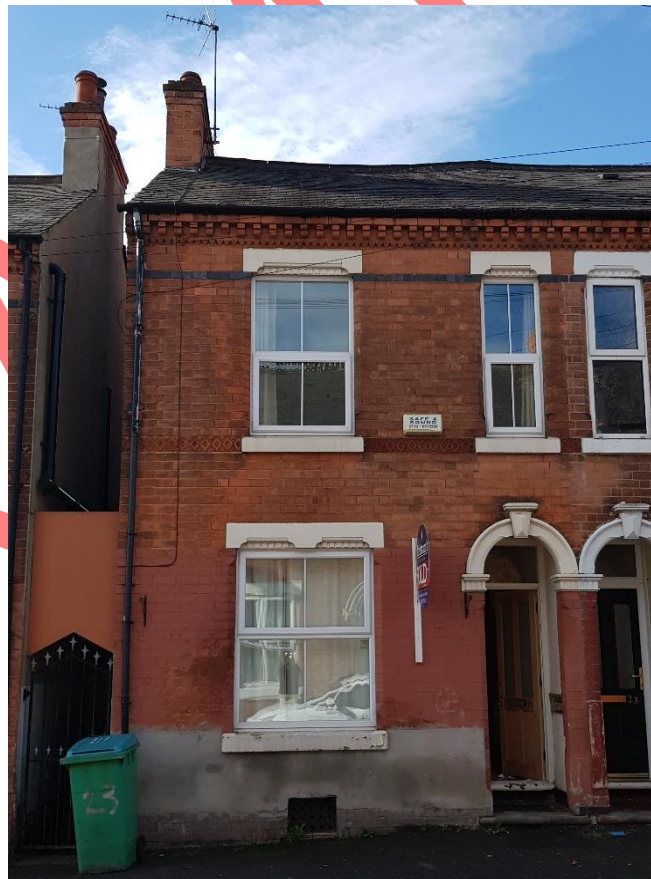
**FIGURE 1**  
Photograph of the front elevation

- The guttering to the front of the property is poor. See comments and recommendations.
- There is severe sag to the roof tiles against the gable wall. See Figure 1, together with comments and recommendations.

- There is a severe sag to the roof ridge tiles within the centre of the property. See Figure 1, together with comments and recommendations.
- The mortar joints to the front building wall are badly weathered in places. See comments and recommendations.

- There is access to the rear gardens of this and other properties by a shared line adjacent to the gable wall. See Figure 1, together with comments and recommendations.
- The front left-hand corner of the gable wall is out of vertical by 1% at ground level.
- The central section of the wall is fairly vertical at ground level.
- The rear left-hand corner of the gable wall is out of vertical by 1% at ground level.
- There is no sign of Damp Proof Course within the gable wall.
- There is damp evident within the gable wall. See comments and recommendations.
- There are numerous perished bricks at low and high levels to the gable wall. See comments and recommendations.
- The mortar joints to the gable wall are badly weathered in places. See comments and recommendations.

A roofer's report is essential at this property. I suspect that new roof tiles and felt will be required to the house, and the rear wing roof requires further investigation. The front guttering appears defective and needs to be repaired as necessary.

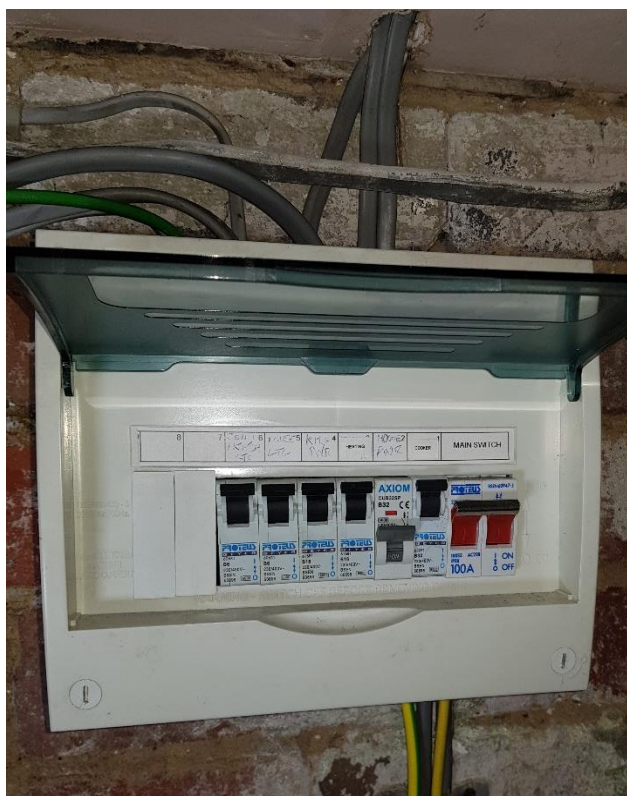
- The cellar sits in a dilapidated condition and appears to be severely damp. See Figure 8, together with comments and recommendations.
- The lounge floor joists are in a good condition.
- The fuse box located within the cellar is recent. See Figure 3.

**FIGURE 3**  
Dated fuse box.

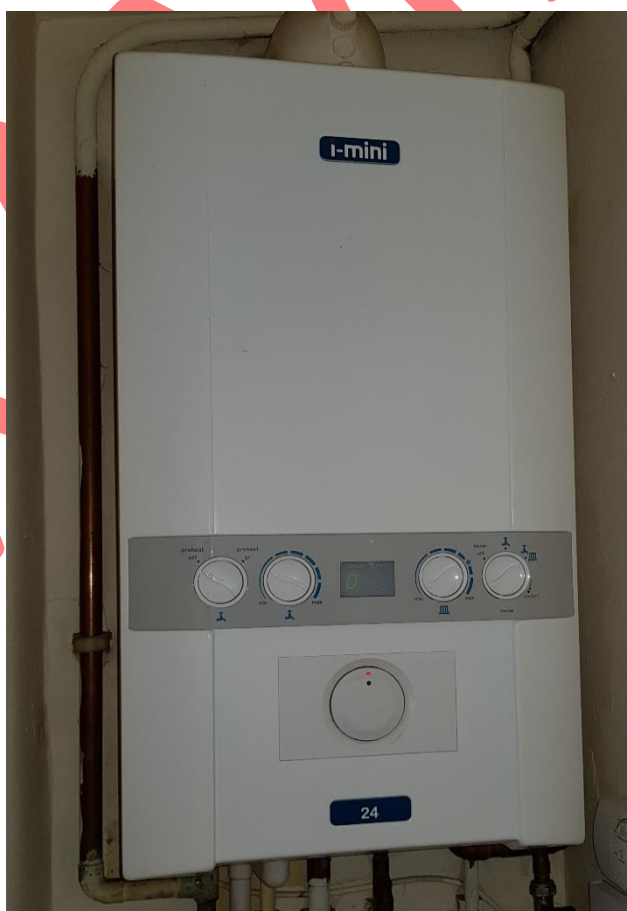
- The solid floor of the kitchen drops towards the rear by some 10mm.
- The right-hand party wall within the kitchen is fairly vertical.
- There is a diagonal crack 10mm in width to the right-hand /party wall of the house to the cellar entrance. See Figure 10, together with comments and recommendations.
- There is no external extractor fan within the kitchen. See comments and recommendations.
- There is a sign of damp affecting the left-hand wall of the kitchen at ceiling level. See comments and recommendations.
- The boiler located within the kitchen is some 12 years old. See comments and recommendations, together with Figure 4.

**FIGURE 4**  
Boiler some 10 - 12 years old.

My client's solicitor needs to ensure that right-of-way arrangements are in place for accessing the rear garden of this and other properties by a shared passageway to the left-hand side of the gable wall. A Gas Safe Report is needed on the condition of the boiler. An electrical report is needed, and Damp and Timber Report are recommended at this property. An extractor fan is needed within the bathroom and kitchen.

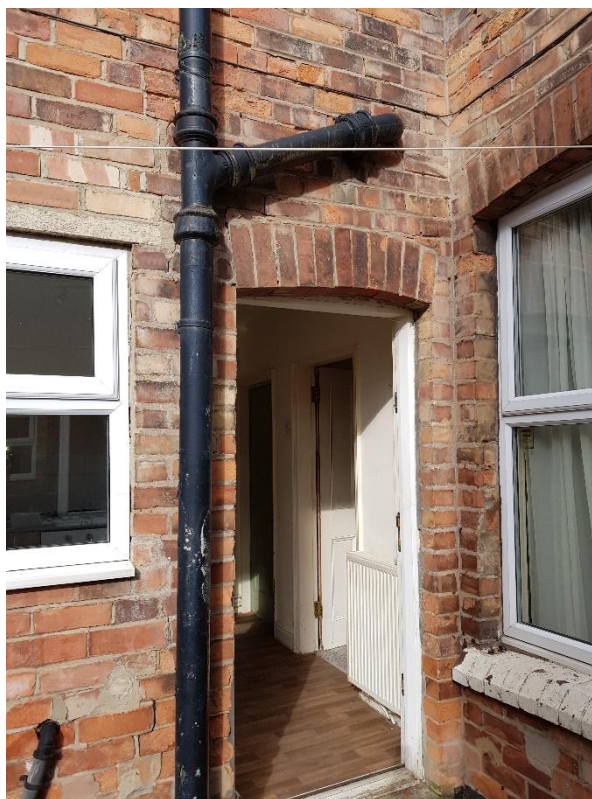
- The house rear wall is out of vertical by 1% at ground level and by 30mm at roof level. See comments and recommendations.
- There is a diagonal crack 2 - 3mm in width below the dining room window. See comments and recommendations together with Figure 5.

- New concrete lintel has been installed to the kitchen window.
- There is diagonal crack 2-3mm in width and significant moment to the kitchen brick arch lintel. See Figure 5, together with comments and recommendations.

**FIGURE 5**  
Lintel failure within the rear wing wall

Cracking noted above the rear dining room window and rear wing flank wall is a characteristic sign of lintel failure. I recommend that Helibars are installed within these areas of brickwork to strengthen brickwork, and areas affected by a significant movement/distortion to brickwork panel and lintel to be rebuilt. There are also numerous perished bricks to the gable and rear walls of the house. I recommend that the perished bricks be replaced.

A 4m long Helibeam will need to be installed at first-floor level to the left-hand flank wall of the rear wing. A 2m HeliBar should be installed to the rear wall above and below the dining room lintel and first-floor bedroom. A significant number of bricks need to be reinstated from the rear wing rear wall and house rear wall. There are approximately twenty bricks to the flank wall of the rear wing which are perished and should be replaced. A further sixty bricks should be replaced as they have perished against the house gable wall.

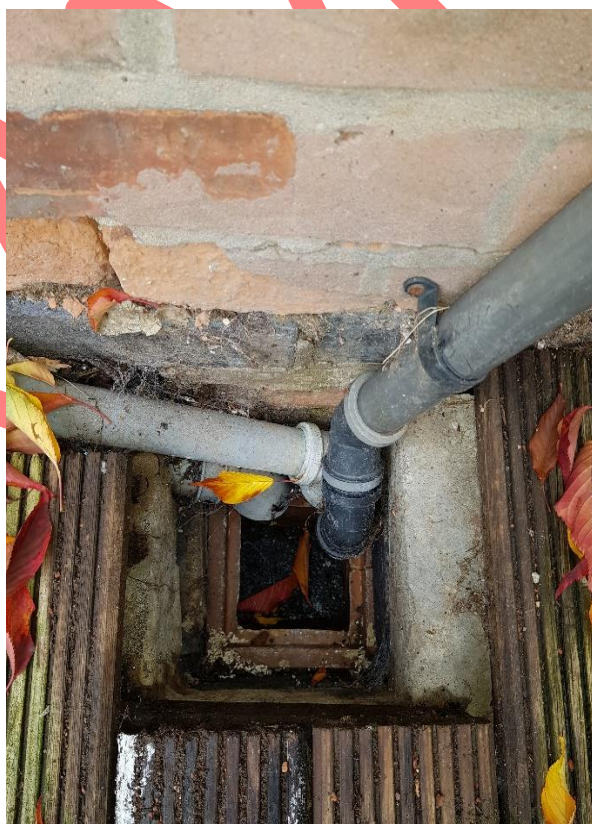
- The rear gully is full of debris and appears blocked. See Figure 6, together with comments and recommendations.
- The rear wing rear wall is out of vertical by 2% at ground level and by 30mm at roof level.

**FIGURE 6**  
The blocked gully to the rear of the property

There are no signs that the foul drainage system of this property is affecting the damage noted within my report. However, the gully to the rear of the property is blocked up. The guttering, rainwater downpipes and gullies of the property are to be inspected for blockage and leakage.

The blocked gully to the rear wing is located close to the house rear wall area. When excess water is discharged close to a building it can have an adverse effect on the subsoil which provides support for the building foundations. My observations and the results of the level survey carried out on the walls and floors of the house confirmed the evidence of both historic and progressive differential settlement of the foundation.

The guttering, rainwater downpipes and gullies of the property are to be inspected for blockage and leakage. Any defective guttering and blocked gully to the rear of the property need to be repaired and reinstated as necessary.

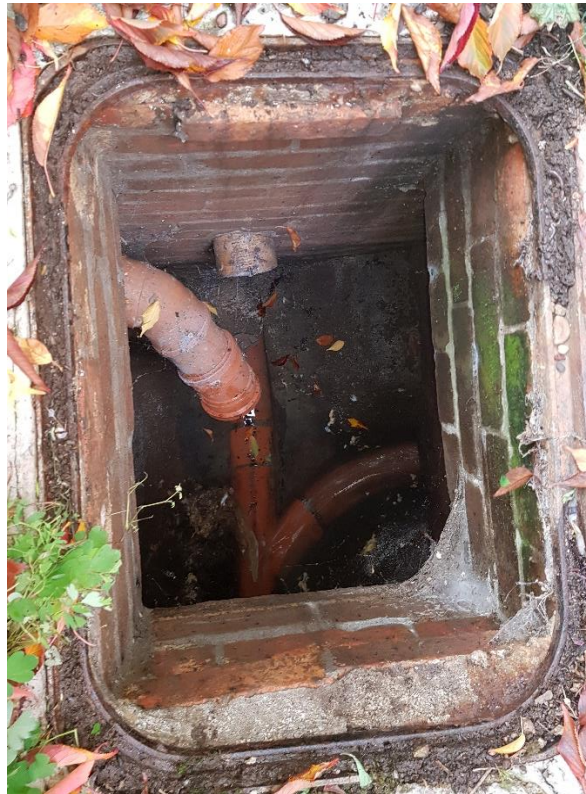
**FIGURE 7**

- There are numerous perished bricks within the chimney stack. See comments and recommendations.
- The manhole cover was lifted to the left-hand side of the rear wing, with an invert level of approximately 1.5m below ground level. Some debris was noted within the manhole and the cast iron cover is severely damaged. See Figure 7, together with comments and recommendations.
- There is a tree some 6m tall located some 3.5m away from the rear wing left-hand corner. See comments and recommendations.

Debris on foul sewer which runs parallel to the rear and gable wall of the house.

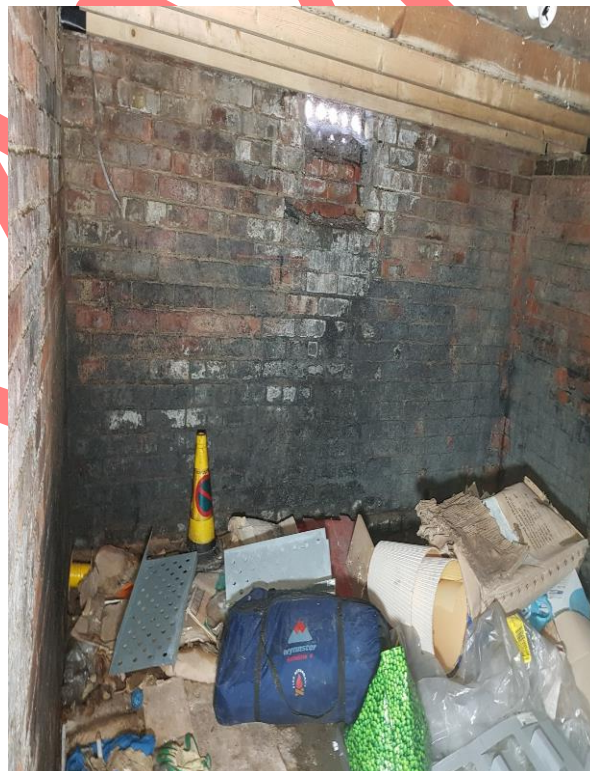
**FIGURE 8**

Severe dampness within the cellar.

recommended as there is severer damp internally within the basement walls and floors and localised damp within the front and rear ground level living area. There is dampness to the chimney breast in the lounge and dining room. This will require further investigation. I would recommend that disused flues should be adequately capped and ventilated.

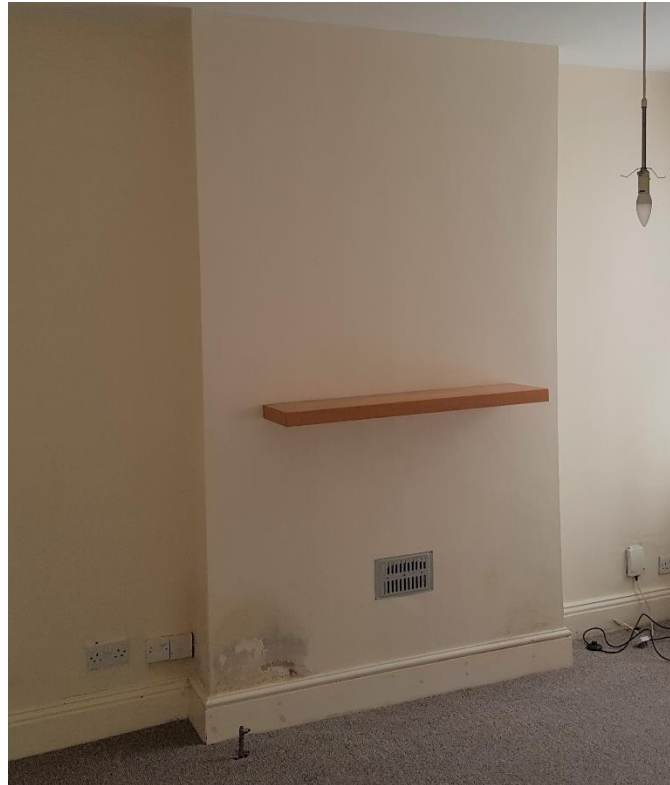
**FIGURE 9**

- There is a sign of damp affecting the gable wall of the dining room and the chimney breast at a low level. See comments and recommendations, together with Figure 9.

Damping to the dining room and chimney breast.

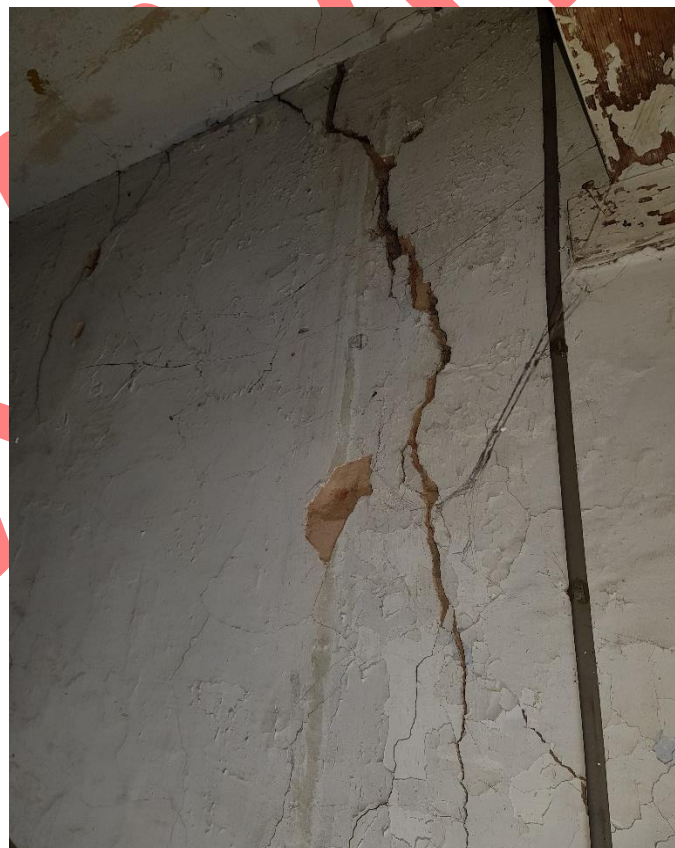
**FIGURE 10**

Significant cracking to the party wall at ground level

All the cracks within the external walls and internal party wall to be stitched using Helifix reinforcement bars. Cracks to the internal walls and ceilings should be repaired with Expamet mesh/lath and re-plastered as necessary. All loose brickwork and eroded mortar should be re-pointed.

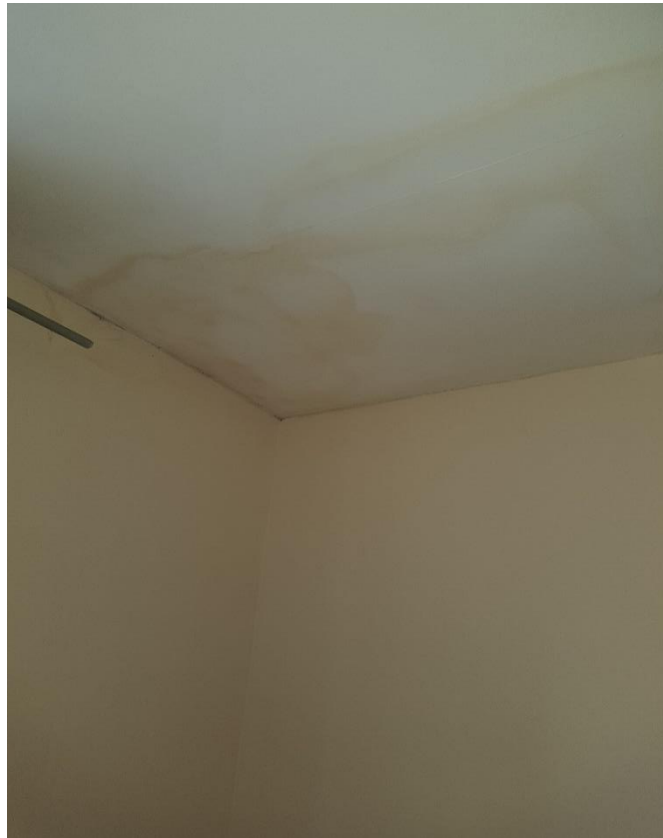
- The suspended timber floor of this bedroom drops towards the rear by some 20mm - 30mm.
- The front wall of the bedroom is fairly vertical.
- The right-hand wall is fairly vertical.
- The left-hand / gable wall is fairly vertical.
- There are hairline ceiling cracks within this room.
- There is a vertical hairline crack above the door lintel.
- There are damp and roof leakage evident within the ceiling to the left-hand corner. See Figure 11, together with comments and recommendations

**FIGURE 11**  
Discolouration of the front bedroom ceiling.

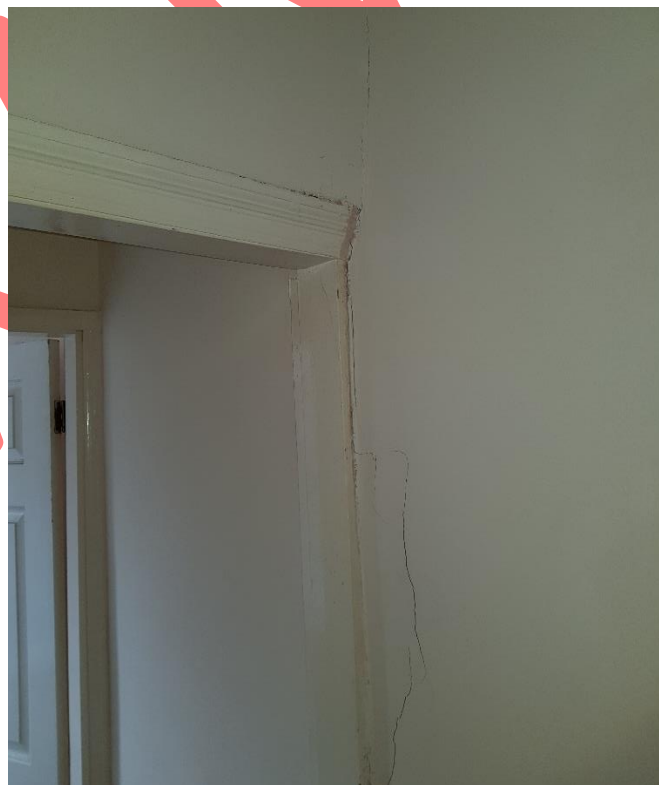
- The suspended timber floor of the landing drops towards the rear by some 45mm.
- The right-hand/party wall within the stairs is at a vertical of 1%.
- The rear wall/toilet partition is at a vertical of 2%.
- The door frame to the toilet was found to be out of square by some 15mm.
- There are diagonal cracks 2mm in width to the rear bedroom partition. See comments and recommendations.
- There is a diagonal crack 2mm in width above the door frames to the toilet area. See comments and recommendations.
- There are vertical cracks 2mm – 3mm in width to the party wall. See Figure 12, together with comments and recommendations

**FIGURE 12**  
Cracking to the party wall at first-floor level.
