IKT CONSULTING
STRUCTURAL ENGINEERS LIMITED

Client: Mr A. Client
Site Address: 00 Calverton Road, Nottingham
Report: Structural Inspection
Job No.: IKT0000
Date: 1 April 2024

1 INTRODUCTION

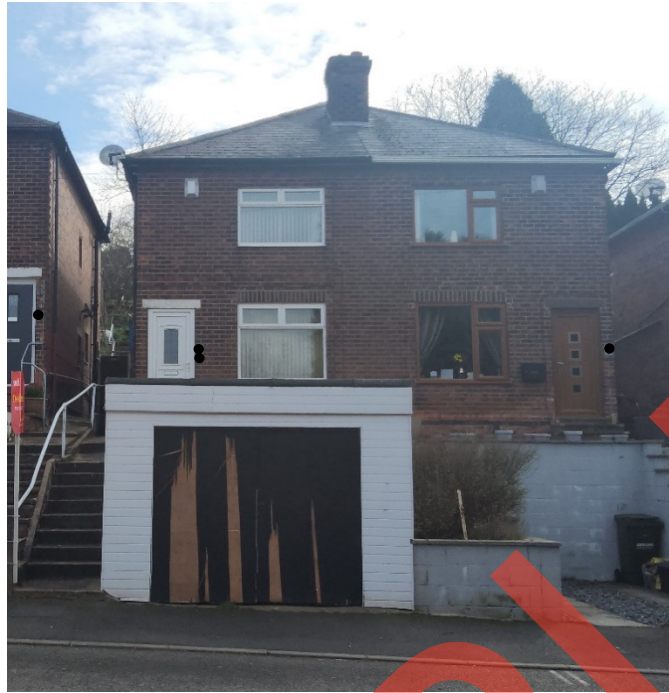
FIGURE 1
Photograph of the front elevation

- The roof ridge bedding is poor in places.
- There is a chimney flaunching appeared poor and vegetated with moss in places.
- The left hand corner is fairly vertical.
- The central section is fairly vertical.
- The right hand party wall area is fairly vertical.
- The front windowsill is fairly level.
- There is a diagonal crack approximately 1.2 mm in width located above the lounge window. Repointed and reopened. See Figure 4, together with comments and recommendations.
- There is a diagonal crack approximately 1 mm in width located below the lounge window.
- The concrete patio has settled slightly away from the front wall.
- The garage flat roof is vegetated with moss.
- The garage front right hand panel is distorted.

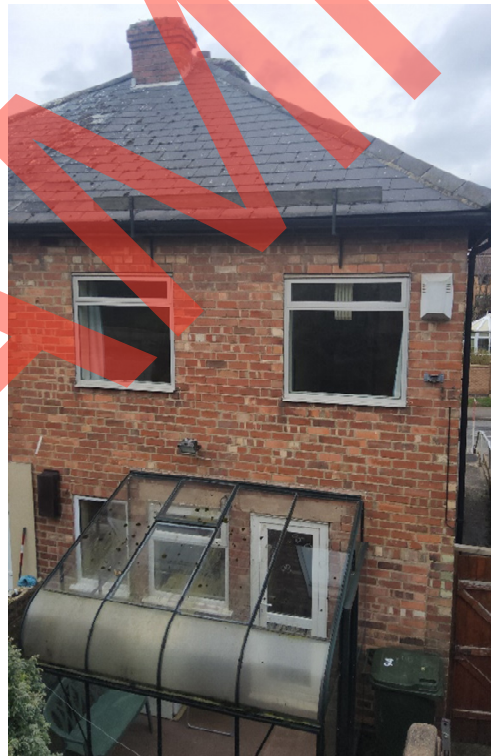
FIGURE 2
Photograph of the rear elevation.

- The roof is vegetated with moss.
- The roof hip ridge bedding is poor and distorted in places.
- There is a rear chimney stack vegetated, and mortar joints are poor in places.
- The rear corner is at a vertical by 1%.
- The central section is fairly vertical.
- The right hand corner is fairly vertical.
- There is a minor crack above the rear door lintel, and perished mortar joints.
- The blockwork wall to the right hand of stairs leading to the upper rear garden is distorted significantly in places. See Figure 6, together with comments and recommendations.
- The rear retaining wall is at a vertical by 4.5 %. See comments and recommendations.
- There is a crack 3mm in width to the left-hand section of the rear retaining wall. See comments and recommendations.

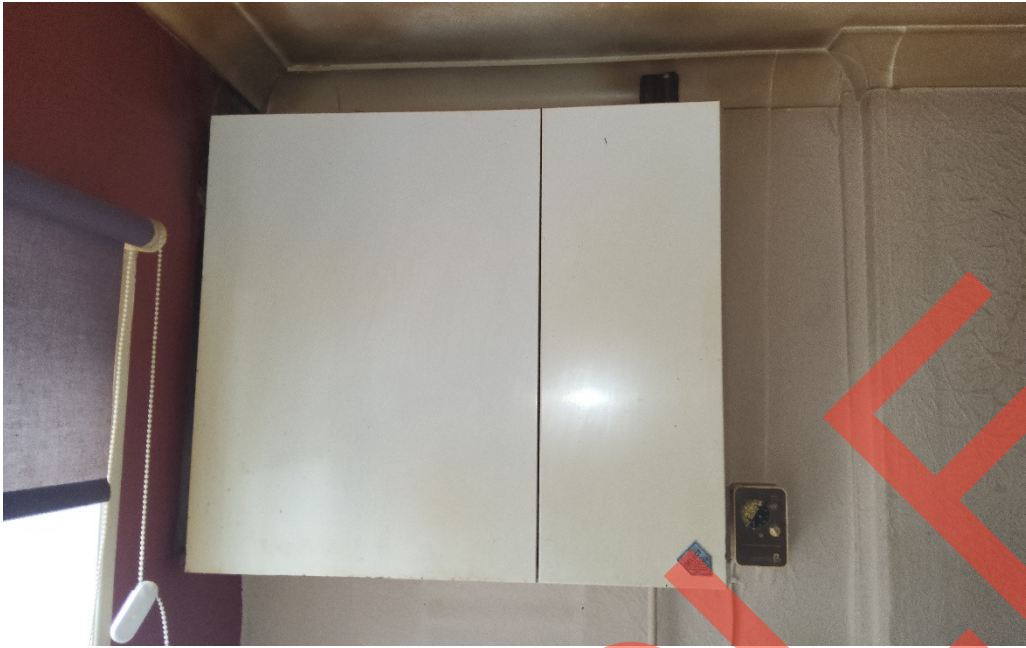
The Boiler within the kitchen is dated.

FIGURE 3
Dated boiler.

An Electrical Report is required. A Gas Safe report is needed on the condition of the boiler. We suspect that a new boiler will be needed. Asbestos survey should be carried out within this property. The kitchen and bathroom extractor fan should be installed as necessary. A Roofer needs to be appointed to check the condition of lead flashings to the chimney stack. The possible leaks and discolouration in the loft need to be investigated and reinstated as necessary. The mortar bedding to the front and rear hip tiles needs to be repointed in places. Moss should be cleared from the roof. Within the loft space, two vertical supports should be added to the rear and left-hand roof purlins. The clients' solicitor needs to check that Building Regulation Consent was obtained for the removal of the chimney breast within the kitchen area. A CCTV drainage survey is desirable due to the age of this property.

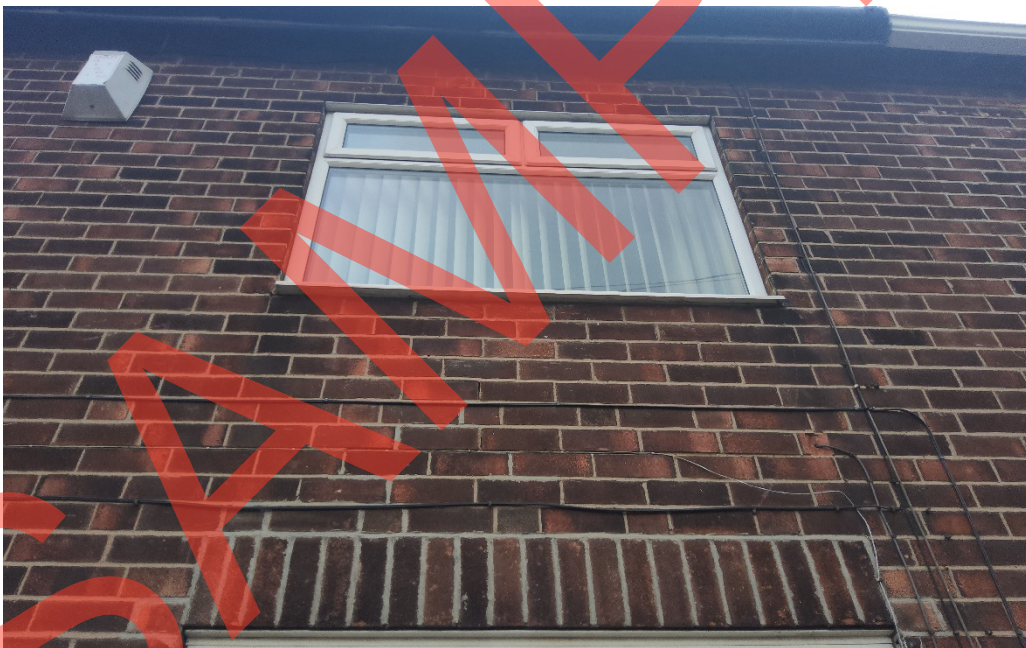
FIGURE 4
Cracking above the lounge window.

Cracking within the external wall can allow moisture to penetrate the building. All cracks wider than 1mm should be repaired using Helifix or similar twisted reinforcement bars and installed in accordance with the manufacturer's details and specifications. The crack above the windows is a characteristic of lintel failure. Further investigation should be carried out to establish the lintels above all openings within the elevations. Proprietary lintels should be installed above any wall opening found without an adequate lintel. Any necessary repairs to the masonry should be done so that the re-pointing matches the existing elevations. The rear chimney stack needs to be repointed in places. Although no serious disrepair could be seen from ground level,

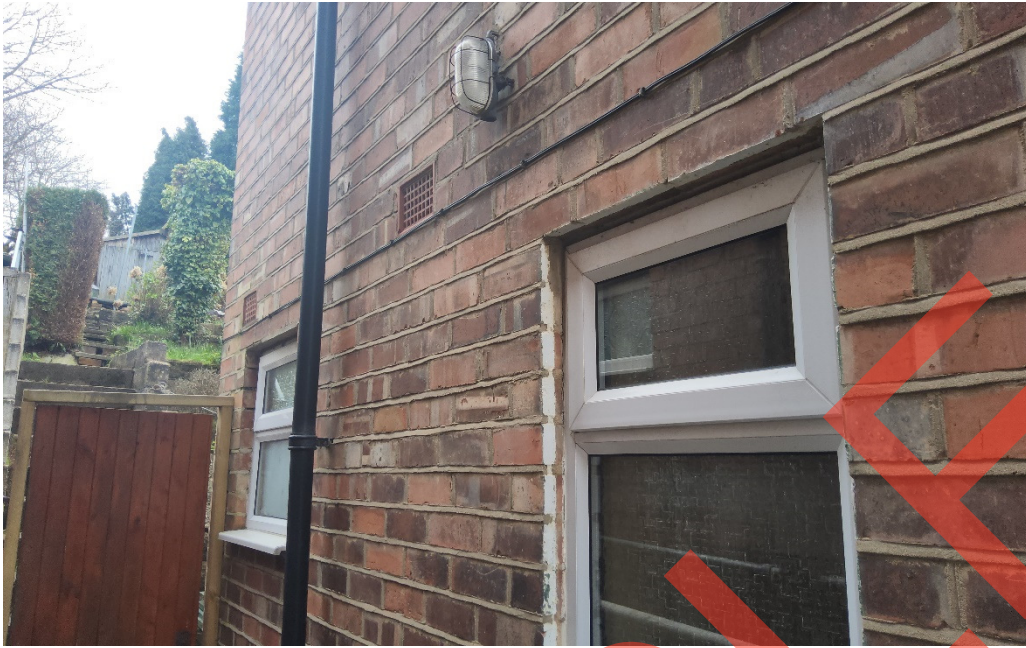
- The roof hip ridge bedding is poor in places.
- The front corner is fairly vertical.
- The central section is fairly vertical.
- The rear corner is fairly vertical.
- The rear windowsill is fairly level.
- There is no lintel above the toilet and bathroom windows. See Figure 5, together with comments and recommendations.
- There is a short crack 1mm in width below the first floor landing window. See comments and recommendations.

FIGURE 5
Lack of lintols above windows.

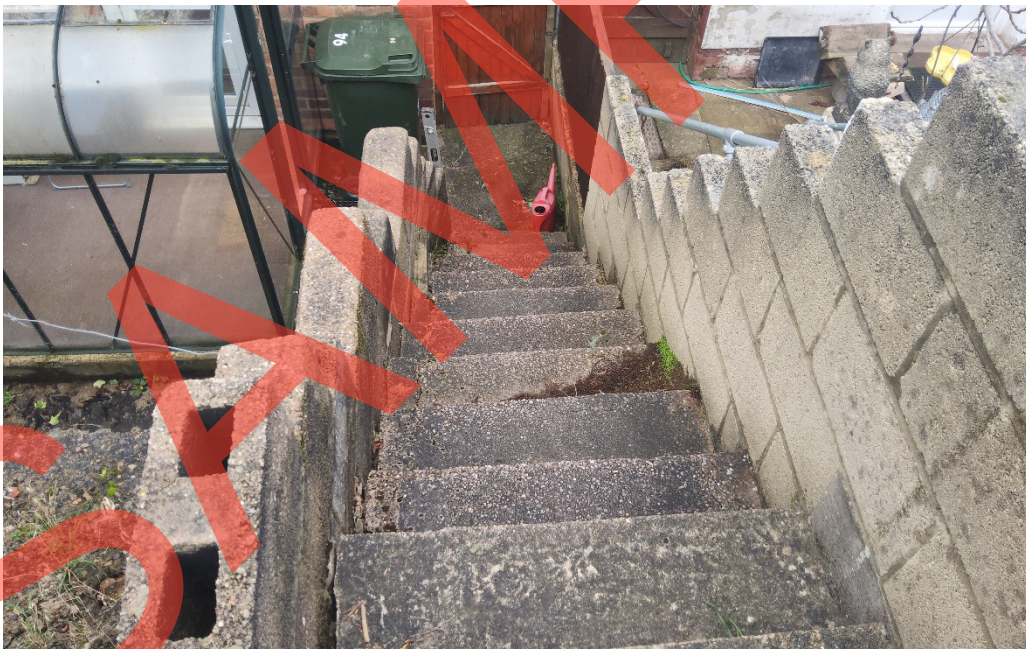
FIGURE 6
Distorted blockwork wall to the garden stairs.

The right hand wall of the staircase leading to the upper garden should be rebuilt as necessary. The crack within the rear retaining wall needs repaired with Helibars or similar. There are no weep holes noted within the rear garden retaining walls. Poor or inadequate or lack of drainage within a garden retaining wall can cause water to accumulate behind the wall and increase the lateral forces acting on the wall. This can also cause the subsoil which provides support to the base of the wall to soften and lose strength. We recommend that weep holes be drilled through the walls to allow water to escape from behind the walls. There was no access to the prefabricated garage during our inspection, however the front panel appeared distorted and should be reinstated. Further inspection is desirable to check the condition of the garage.

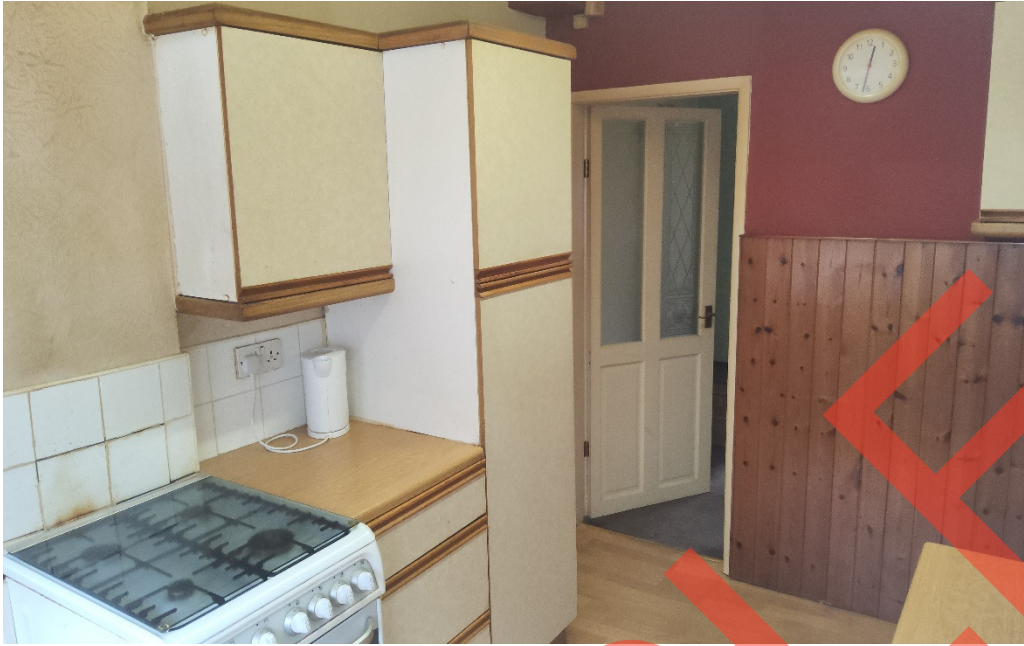
- The solid floor drops towards the rear by some 30mm.
- The right-hand wall is fairly vertical.
- The left-hand partition is fairly vertical.
- Chimney breast appeared to have been removed within the kitchen. See Figure 7, together with comments and recommendations.
- There is no extractor fan within the kitchen.

FIGURE 7
Chimney breast missing within the kitchen.

The purlins are poorly supported within the loft space. We would recommend that roof strengthening works be carried out within the loft space. Chimney breast appeared to have been removed from the kitchen. The clients' solicitor needs to check that Building Regulation Consent was obtained for the removal.

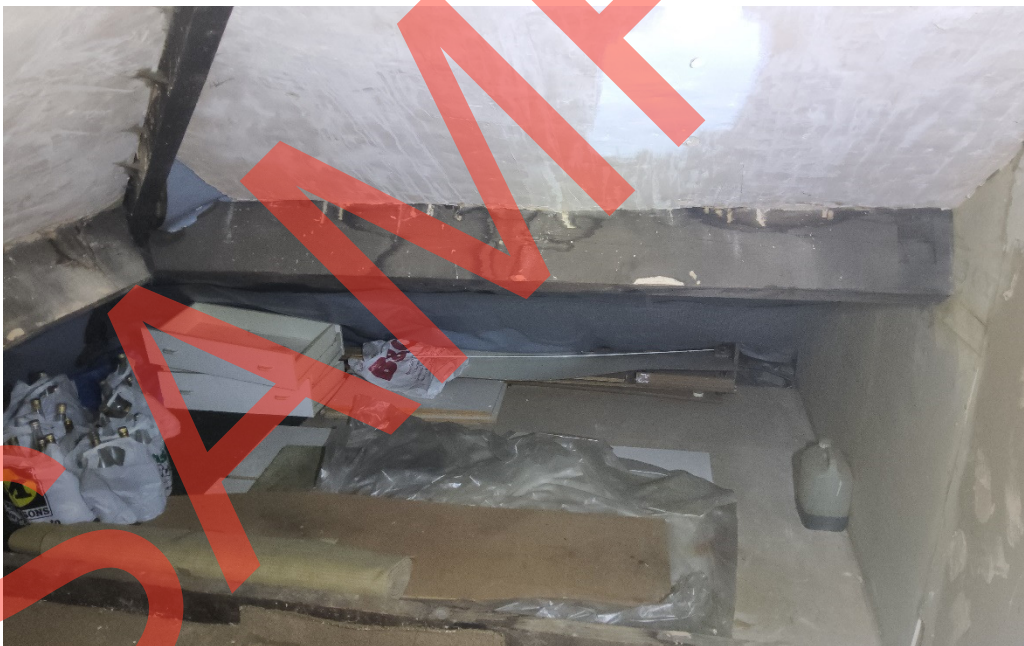
- The purlins are poorly supported within the rear left hand corner. See Figure 8, together with comments and recommendations.
- There are signs of leaks and water stains on purlins. See Figure 8, together with comments and recommendations.
- There are signs of water ingress to front chimney breast.
- There is a crack within the left hand purlin.
- the central section of the loft is boarded.

FIGURE 8
Poorly supported purlins with stains and cracking.
