IKT CONSULTING
STRUCTURAL ENGINEERS LIMITED

IKT0000/DI/01

Re: 0, Park Street, Birmingham, B2 4AL

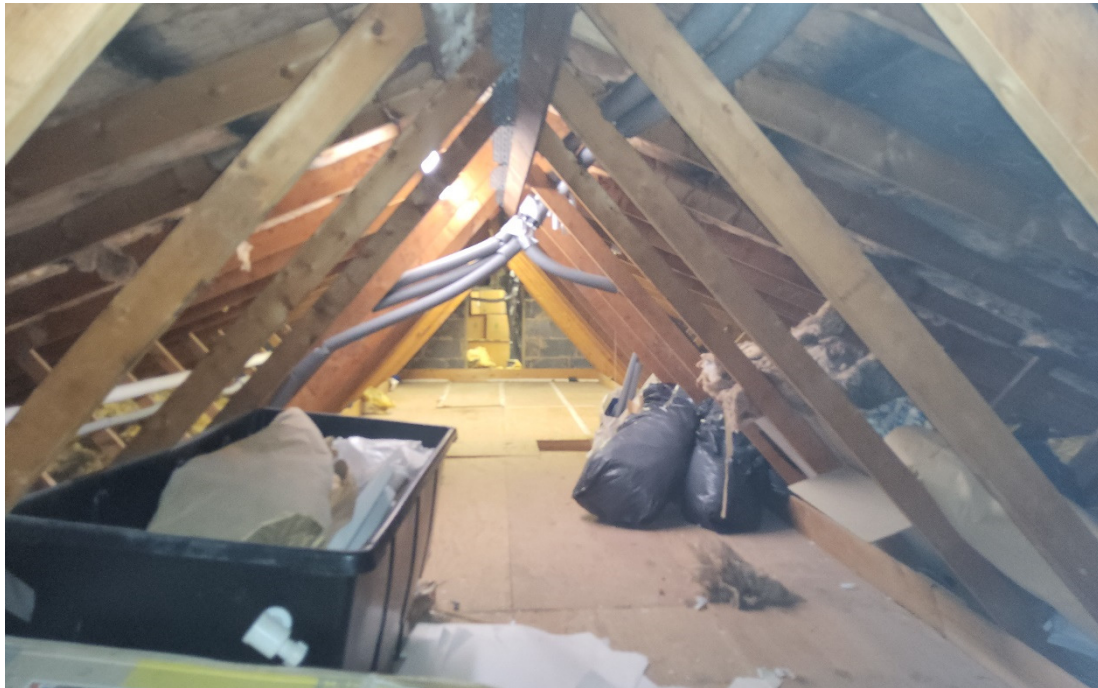
FIGURE 1
Loft space

Our observations and the results of the level survey carried out on the property confirmed that the walls of the house are fairly plumb and plane, showing the usual signs of weathering but are serviceable. The roof slopes and ridge appear 'true' and within acceptable limits, showing no significant dip or deflection, thereby suggesting the roof structure beneath is satisfactory. However, lateral restraint straps and some longitudinal bracings are missing within the loft space.

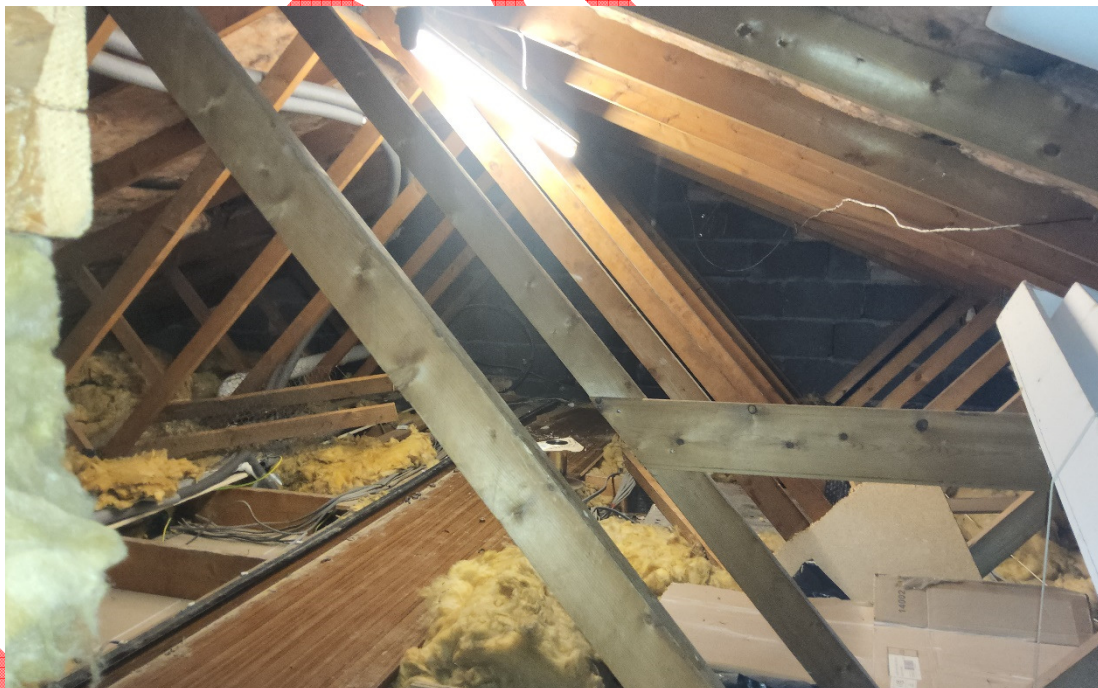
FIGURE 2
Truss roof without restraint straps.

Galvanized steel lateral restraint straps (structural straps) should be introduced to provide a positive connection between the gable walls and roof (rafters and ceiling joists). See Figure 3. These straps are normally 30mm x 5mm in section and are screwed to the ceiling joists and the rafters and bolted to the wall. The straps are usually spaced at not more than 2.0m centres. Within the main loft space, 10No structural straps should be installed within the left-hand gable and 10No. to the right-hand gable, tying gable walls to the roof trusses i.e. rafters and ceiling joists. Bracing members should be installed to secure the trusses within the loft space. See Figure 4. All strengthening work should be carried out in accordance with Building Regulations Part A.
