IKT CONSULTING
STRUCTURAL ENGINEERS LIMITED

Site Address: Silver Street, Leicester

Report: Structural Inspection – External Fire Escape

Date: 1 April 2024

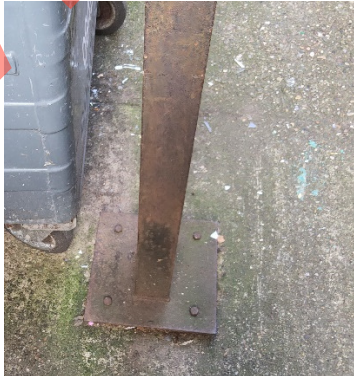
1.1	<p>There is slight corrosion and a loss of the protective coating on the columns, base plates and their fixings.</p> <p>Clean the steel with a wire brush or buff the affected area to remove rust and two coats of zinc-rich epoxy paint or similar anti-rust to the steel surfaces.</p>

3

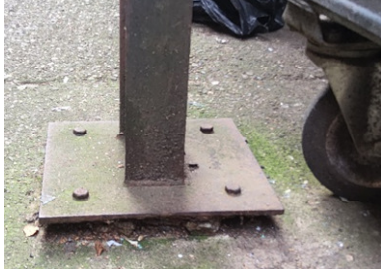
1.2	<p>The cement grout applied to the baseplates exhibits signs of deterioration and weathering in places.</p> <p>Repair and apply cementitious grout to secure the baseplate to the concrete slab.</p>

3

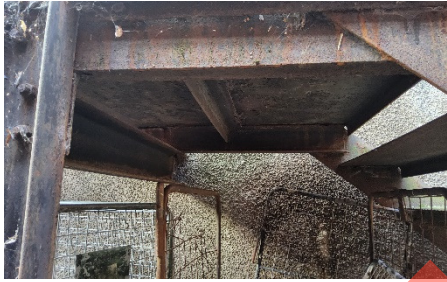
1.3	<p>The steel beams that support the first floor and half-landings display</p>

<p>moderate corrosion and areas of structural deterioration.</p> <p>Clean the steel with a wire brush or buff the affected area to remove rust and two coats of zinc-rich epoxy paint or similar anti-rust to the steel surfaces.</p>

3

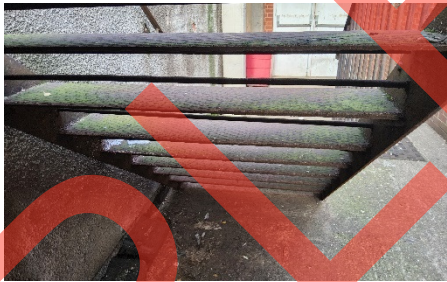
1.4	<p>The steel flat stringers and their fixings, which support the balustrade and treads, show signs of corrosion in specific areas.</p> <p>Clean the steel with a wire brush or buff the affected area to remove rust and two coats of zinc-rich epoxy paint or primer to the steel surfaces.</p>

2

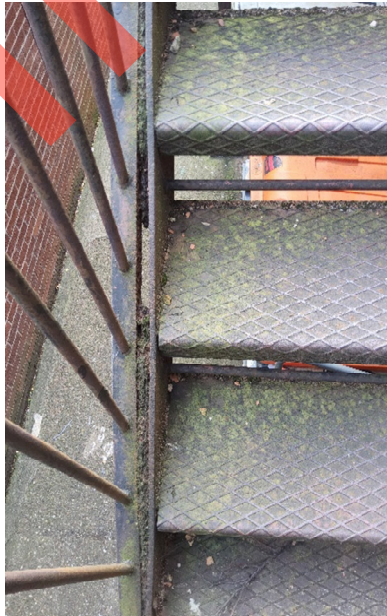
1.5	<p>The balustrades running alongside the staircase exhibit moderate corrosion, and there is noticeable poor packing and weathered shims at the stringer fixing points.</p> <p>Provide shim to fill the gaps. Clean the steel with a wire brush or buff the affected area to remove rust and two coats of zinc-rich epoxy paint or similar anti-rust to the steel surfaces.</p>

3

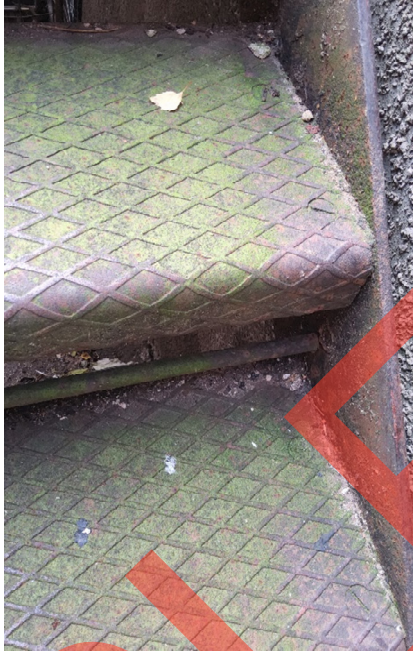
1.6	<p>The treads and landing plates display moderate corrosion, with moss growth in some areas. Furthermore, there is a loose bar within the lower section of the</p>		2

1.7	<p>staircase.</p> <p>Clean the steel with a wire brush or buff the affected area to remove rust and two coats of zinc-rich epoxy paint or similar anti-rust to the steel surfaces. Reinstate/weld all loose tread bars. Remove moss.</p> <p>The steel plate on the first-floor landing shows moderate distortion and showing signs of corrosion, with moss and vegetation present in certain areas. Additionally, there is a noticeable gap between the steel plate and the concrete structure of the staircase.</p> <p>Clean the steel with a wire brush or buff the affected area to remove rust and two coats of zinc-rich epoxy paint or similar anti-rust to the steel surfaces. Reinstate/replace the landing plate to adequately extend the concrete structure to level. Remove all vegetation and moss.</p>
